DOT HS 813 669

December 2024

Testing Rear-Door-Logic Based Unattended Child Reminder Systems

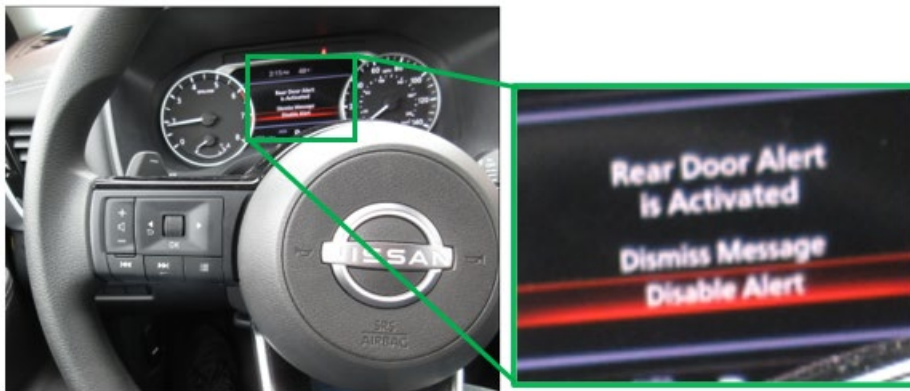
Results: Only two vehicles contained temporary deactivation options for the reminder system, the Nissan Rogue and Hyundai Tucson. In the Nissan Rogue (“alert only” mode and “alert and horn” mode) temporary deactivation was more complicated (moving a cursor using a scroll-wheel and pushing a button) than a short push of a button, therefore meeting criterion 6.

Figure 3. Nissan Rogue dismissal and temporary deactivation of the alert system

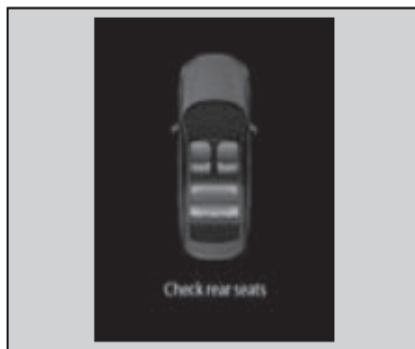
This feature alerts you to the possible presence of passengers or items in the rear seats before you exit the vehicle. It activates when the power mode is set to VEHICLE OFF if the rear doors were opened shortly before or after the power mode was set to ON.

A reminder appears on the driver information interface and an alert will sound when the power mode is set to VEHICLE OFF.

Figure A-6. Honda Civic owner's manual

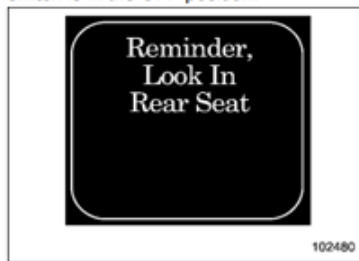
This function will be activated when the rear doors are opened and closed.

It alerts the driver by warning messages on the display and beeps when the ignition switch is in the OFF position.

- This function does not directly detect passengers and cargo in the rear seat.
- This function detects the opening and closing of the rear doors. In this situation, there is the possibility that the following phenomenon may occur.
 - It may alert the driver even if there are no passengers or cargo in the rear seat.
 - It may not alert the driver even if there are passengers and cargo in the rear seat.
- This function can be turned ON/OFF using the meter customizing function. Refer to "Function settings and adjustments on the combination meter display (color LCD)" ⇨ P26.
- The ON/OFF setting will not be changed even if the ignition switch is turned to the OFF position.
- The ON/OFF setting will be returned to the default setting if the battery is removed.

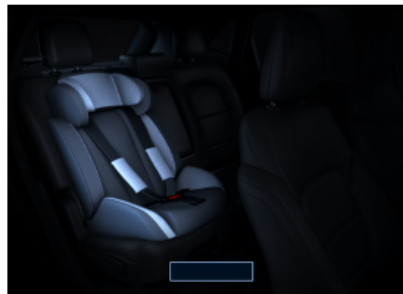
Message
Check rear seats for occupants.

Displays when you switch your vehicle off after the alert conditions are met.

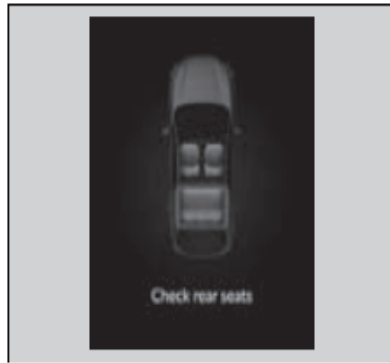
This feature alerts you to the possible presence of passengers or items in the rear seats before you exit the vehicle. It activates when the power mode is set to VEHICLE OFF if the rear doors were opened shortly before or after the power mode was set to ON.

A reminder appears on the driver information interface and an alert will sound when the power mode is set to VEHICLE OFF.

Figure A-18. Honda HR-V owner's manual

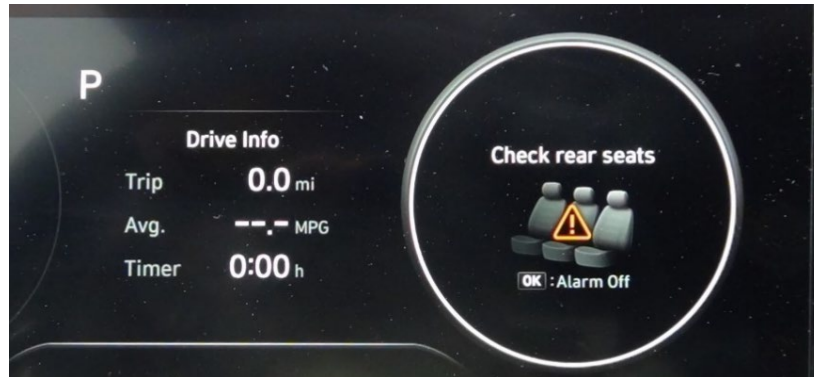
- Upon the driver’s door opening after the vehicle was turned off, there was 1 chime which was different from other tones/alerts with a visual alert that stated, “Check rear seats” and an illustration of rear seats that appeared on the instrument panel. This was presented with the option to “disable” the alert which deactivates a second alert related to the detection system, however his feature was not tested in this study. This visual alert lasted for 5 seconds.

Figure E-1. 2022 Hyundai Tucson visual reminder alert on the instrument panel

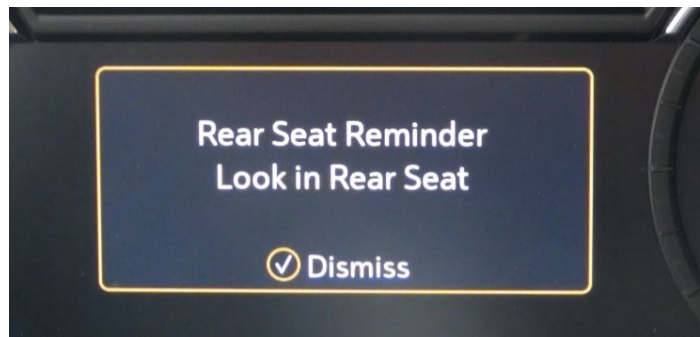
- When the vehicle was turned off there were 5 chimes, which were different than the seatbelt reminder alert but same as tone for putting vehicle in Park and lasted a total of 2 seconds. These chimes accompanied a visual alert that stated “Rear Seat Reminder Look in Rear Seat” that appeared on the instrument panel. The visual alert lasted 10 seconds regardless of whether the driver’s door was opened by the driver.

Figure E-2. 2022 Cadillac XT4 visual reminder alert on the instrument panel

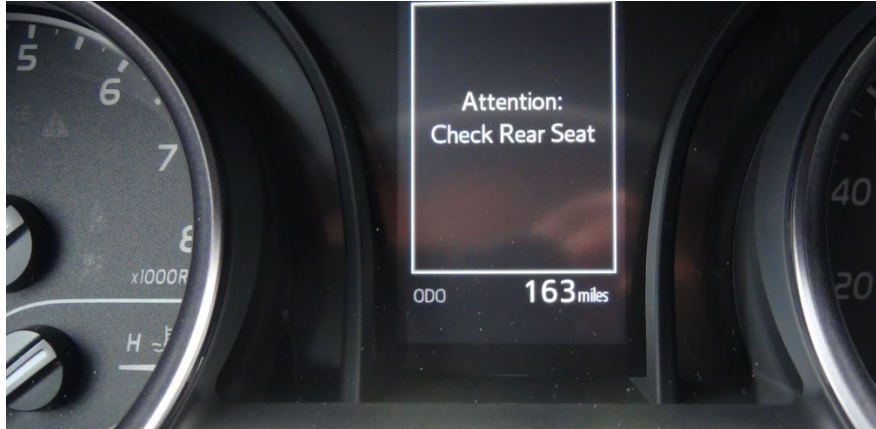
- When the vehicle was turned off there was 1 chime, which was the same tone as the seatbelt reminder alert and was accompanied by a visual alert that stated “Attention: Check Rear Seat” that appeared on the instrument panel. The visual alert lasted 6 seconds or until the driver’s door was opened, whichever occurred first.

Figure E-3. 2022 Toyota Camry visual reminder alert on the instrument panel

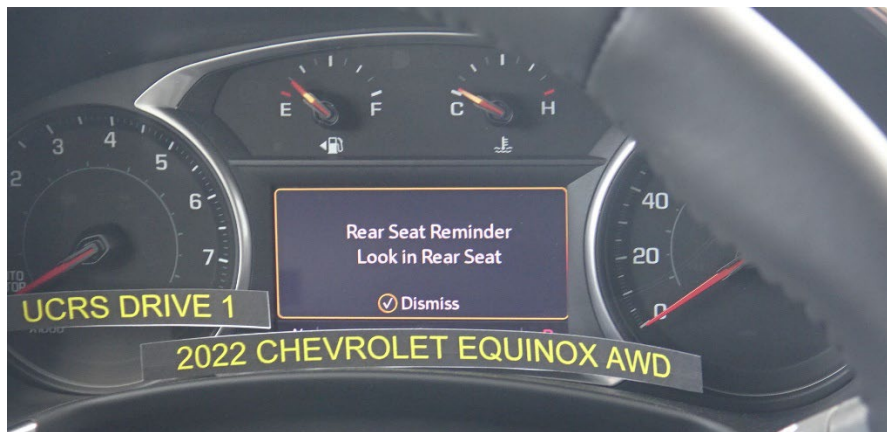
- When the vehicle was turned off there were 5 chimes, which were different from other tones/alerts, and lasted a total of 2 seconds that was accompanied by a visual alert that stated “Rear Seat Reminder Look in Rear Seat” that appeared on the instrument panel. The visual alert lasted 10 seconds regardless of whether the driver’s door was opened by the driver.

Figure E-4. 2022 Chevrolet Equinox AWD visual reminder alert on the instrument panel

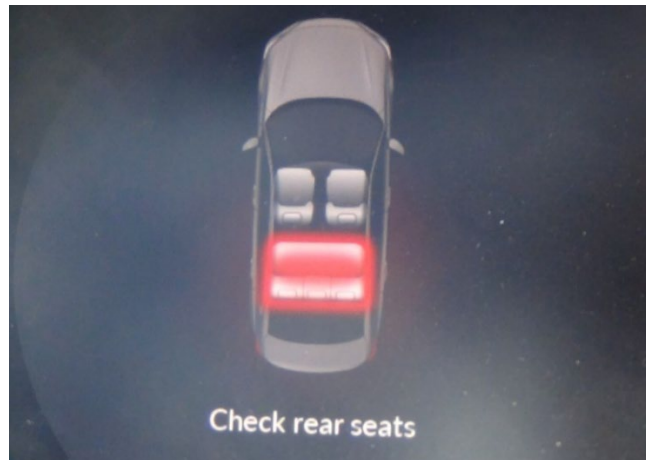
- When the vehicle was turned off there was 1 chime, which was different from other tones/alerts and was accompanied by a visual alert that stated “Check rear seats” that appeared on the instrument panel with an illustration of a vehicle with the rear seats highlighted. The visual alert lasted 10 seconds regardless of whether the driver’s door was opened by the driver.

Figure E-5. 2022 Honda Civic visual reminder alert on the instrument panel

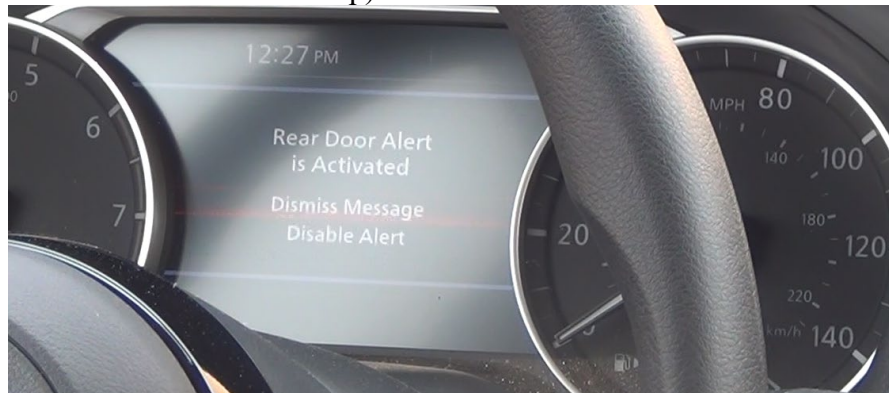
At the beginning of the trip a visual alert that stated “Rear Door Alert is Activated” appeared on the instrument panel if the system was activated by opening and closing a rear door. Along with this alert, two choices were presented to the driver: “Dismiss Message” (alert remains active) or “Disable Alert” (alert was deactivated for that trip).

Figure E-6. 2022 Nissan Rogue alert activation visual alert on the instrument panel

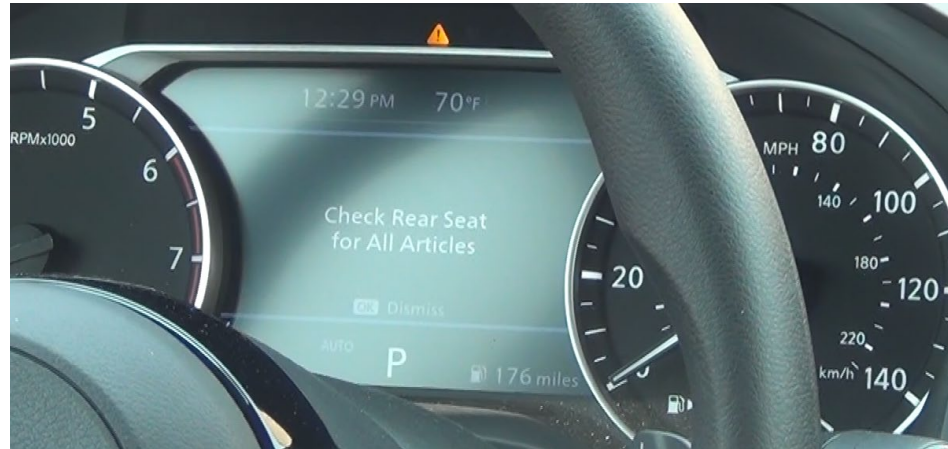
At the end of the trip, an alert was displayed when the vehicle was placed in Park. There was 1 chime, which was the same tone as seatbelt reminder alert, and accompanied the visual alert that stated “Check Rear Seat for all Articles” on the vehicle information display. Along with this alert, the option to: “Dismiss

Message” was presented to the driver. The visual alert was displayed until the driver door was opened (tested up to 4 minutes).

Figure E-7. 2022 Nissan Rogue visual reminder alert on the instrument panel

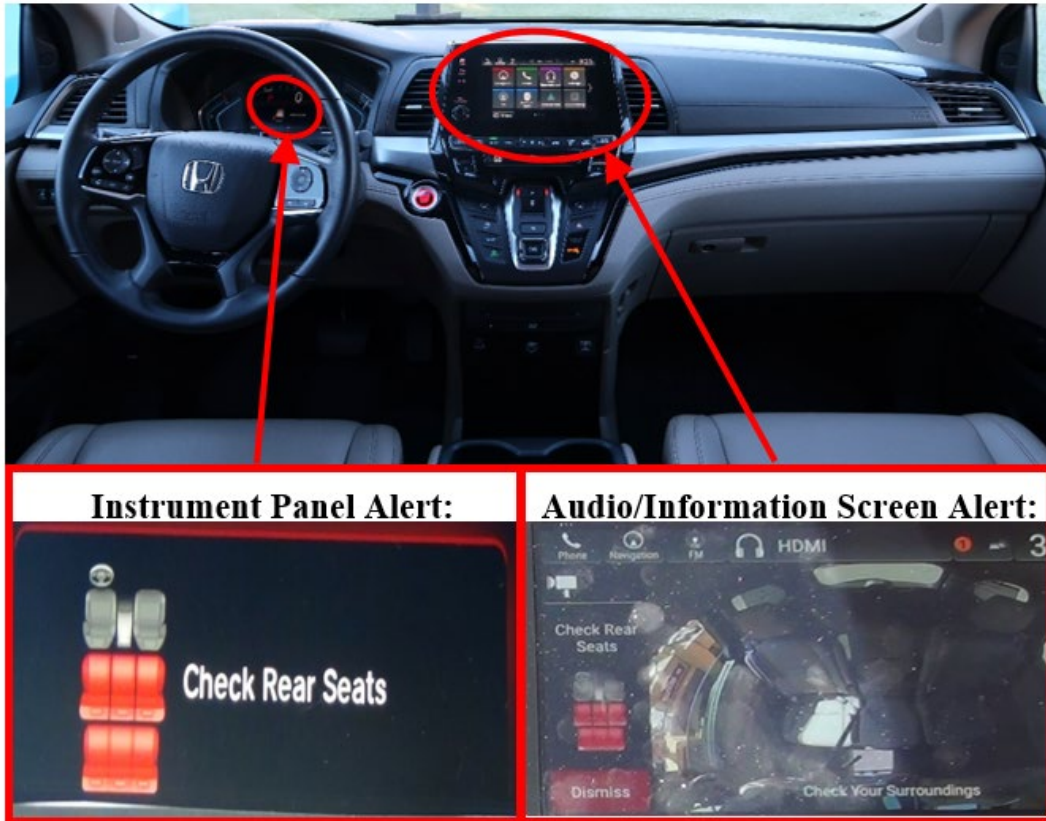
- When the vehicle was turned off there was 1 chime, which was the same tone as the seatbelt reminder alert. This chime was accompanied by a visual alert that stated “Check Rear Seats” that appeared on the instrument with an illustration of a vehicle with the rear seats highlighted. 1 second after the first alert appeared, a live video of the 3rd row seating was displayed on the audio/information screen along with the same visual alert and vehicle illustration that was presented on the driver information interface. Both visual alerts lasted 10 seconds regardless of whether the driver’s door was opened by the driver.

Figure E-8. Honda Odyssey dashboard (top) and close-ups of visual alerts on the instrument panel (bottom left) and audio/information screen (bottom right)

Note: The alerts shown in Figures E-8 are not present in the image of the dashboard of the vehicle as this image was added to show where these alerts are located within the vehicle and was not taken during a test drive.

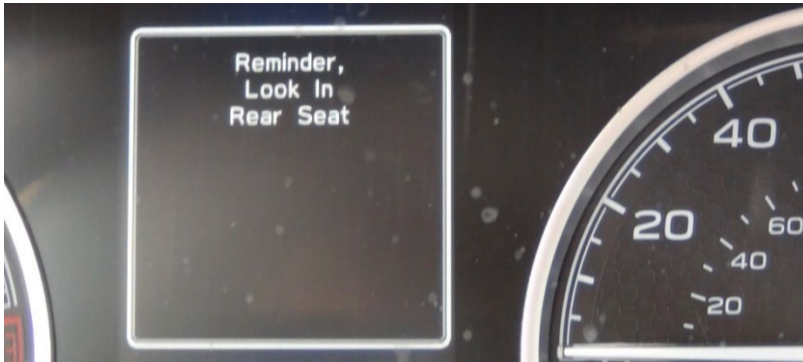
- When the vehicle was turned off there were 2 chimes, which were the same tone as the seatbelt reminder alert, lasting a total of 2 seconds. These chimes were accompanied by a visual alert that states “Reminder, Look in Rear Seat” that appeared on the instrument panel. The visual alert lasted 10 seconds regardless of whether the driver’s door was opened by the driver. This vehicle’s reminder system remained armed until a rear door was opened and closed again, even after key-off.

Figure E-9. 2020 Subaru Forester visual reminder alert on the instrument panel

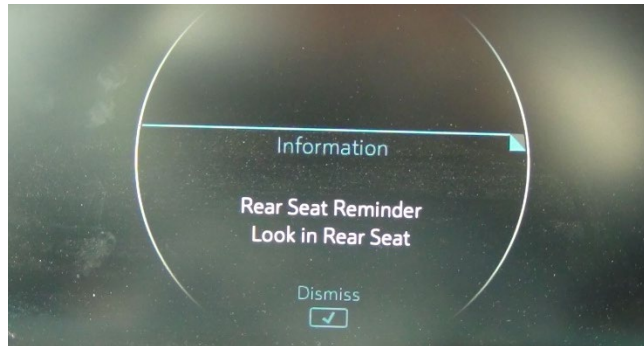
- When the vehicle was turned off there were 5 chimes, which were different than the seatbelt reminder alert but were the same as the tone for putting vehicle in Park and lasted a total of 2 seconds. These chimes were accompanied by a visual alert that stated “Rear Seat Reminder Look in Rear Seat” that appeared on the instrument panel. Along with this visual alert the option to “Dismiss” the alert was presented to the driver. The visual alert lasted 10 seconds regardless of whether the driver’s door was opened by the driver.

Figure E-11. 2017 Chevrolet Bolt visual reminder alert on the instrument panel

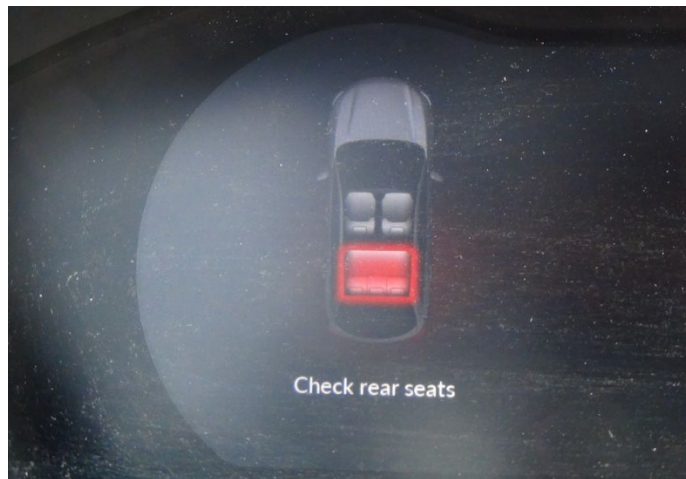
- When the vehicle was turned off there was 1 chime, which was the same tone as the seatbelt reminder alert. This chime was accompanied by a visual alert that stated “Check rear seats” that appeared on the instrument panel with an illustration of a vehicle with the rear seats highlighted. The visual alert lasted 10 seconds regardless of whether the driver’s door was opened by the driver.

Figure E-12. 2023 Honda HR-V visual reminder alert on the instrument panel

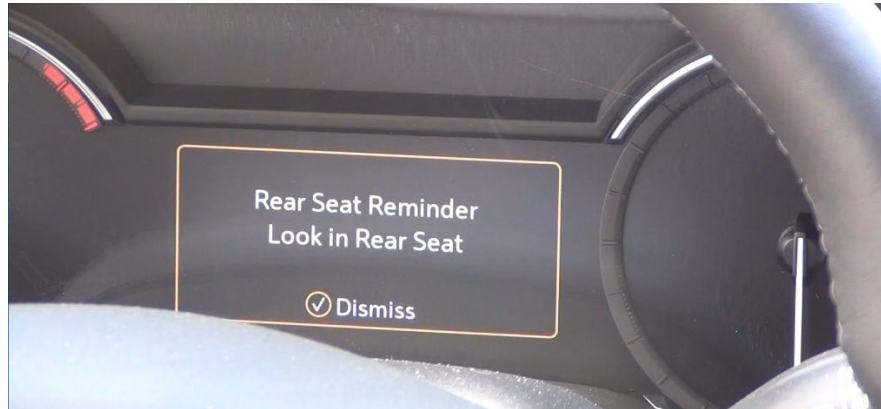
- When the vehicle was turned off there were 2 chimes, which were different than the seatbelt reminder alert but was the same as the tone for putting vehicle in Park and lasted a total of 2 seconds. These chimes were accompanied by a visual alert that stated “Rear Seat Reminder Look in Rear Seat” that appeared on the instrument panel along with an option for the driver to “Dismiss” the alert. The visual alert lasted 10 seconds regardless of whether the driver’s door was opened by the driver.

Figure E-13. 2022 Cadillac CT5 visual reminder alert on the instrument panel
